1 Problem

What When	Problem(s)	Parking garage collapse
	Date	June 23, 2012
	Time	2:18 PM
Where	Different, unusual, unique	Roof leaked since opening
	Facility, site	Elliot Lake, Ontario
	Unit, area, equipment	Roof of shopping center
	Task being performed	Used as parking lot

MALL COLLAPSE

Corrosion after years of leakage results in failure

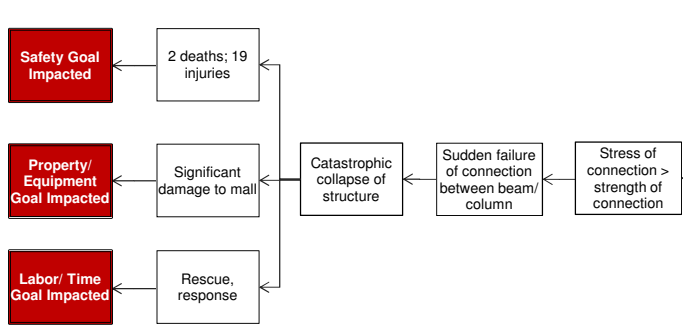
Corrosion of a connection supporting the parking garage decreased its strength to 13% of its original capacity, meaning that on that fateful day, one car driving over it resulted in its fatal collapse. But the more important story is that of how the corrosion was allowed to increase unchecked, due to leakage that had been noted since the opening of the mall.
