ANTARES CARGO ROCKET EXPLODES SECONDS AFTER LAUNCH

Russian engines from the 1960s eyed as possible cause

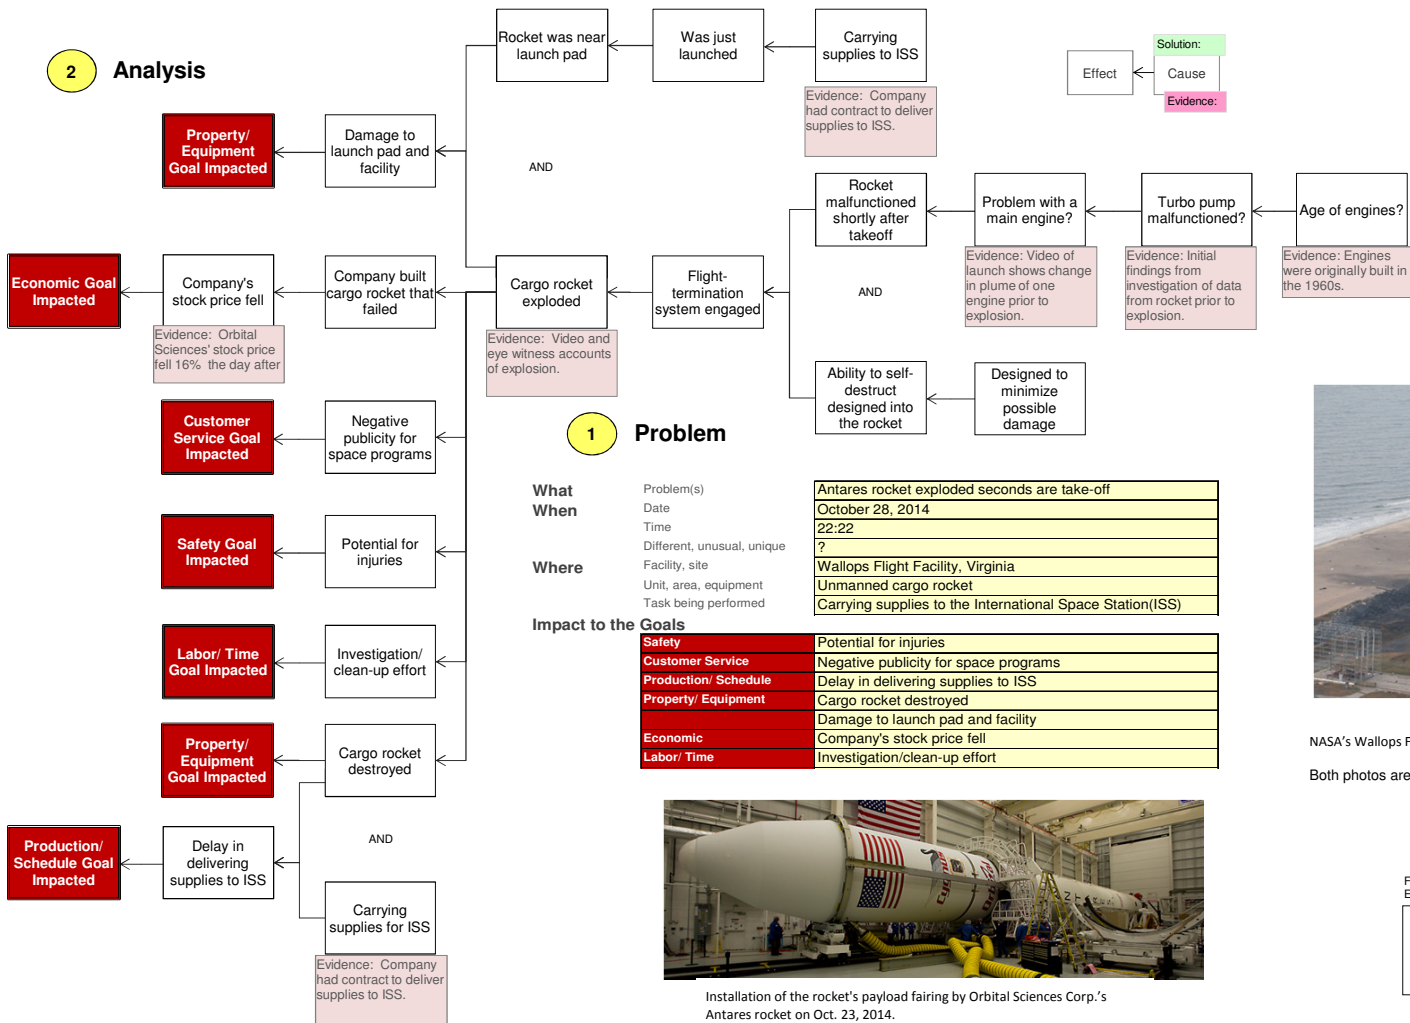
2 Analysis

NOTE: Read the Cause Map from left to right with the phrase "Was Caused By" in place of each arrow.

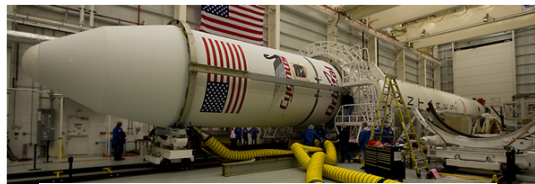
Installation of the rocket's payload fairing by Orbital Sciences Corp.'s Antares rocket on Oct. 23, 2014.

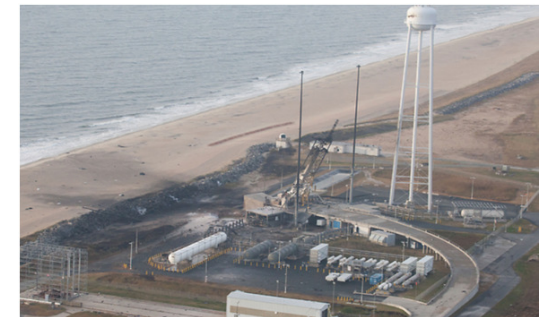
NASA's Wallops Flight Facility after failure of the Antares rocket on October 28, 2014.
