SL-1 explosion, January 3, 1961

The only fatal reactor accident in the United States occurred on January 3, 1961, when an Army prototype known as SL-1 (for stationary, low power reactor, unit 1) exploded, killing the 3 operators who were present. We'll use the SL-1 tragedy as an example of how the Cause Mapping process can be applied to a specific incident. A thorough root cause analysis built as a Cause Map can capture all of the causes in a simple, intuitive format that fits on one page.

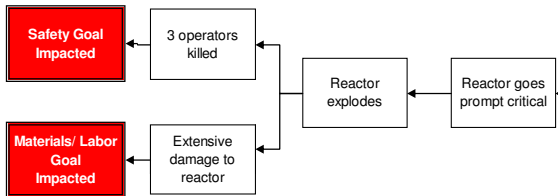
The SL-1 tragedy killed the three operators present, which is an impact to the safety goal. Another goal is that there be no damage to the vessel. In the case of SL-1, the vessel sustained extensive damage.

The loss of life and vessel damage were both caused by the reactor exploding. The reactor exploded because it went prompt critical (an uncontrollable, exponentially increasing fission reaction). The reactor went prompt critical because withdrawal of the central rod can cause prompt criticality and because the rod was rapidly, manually lifted 26.4" out of the core.

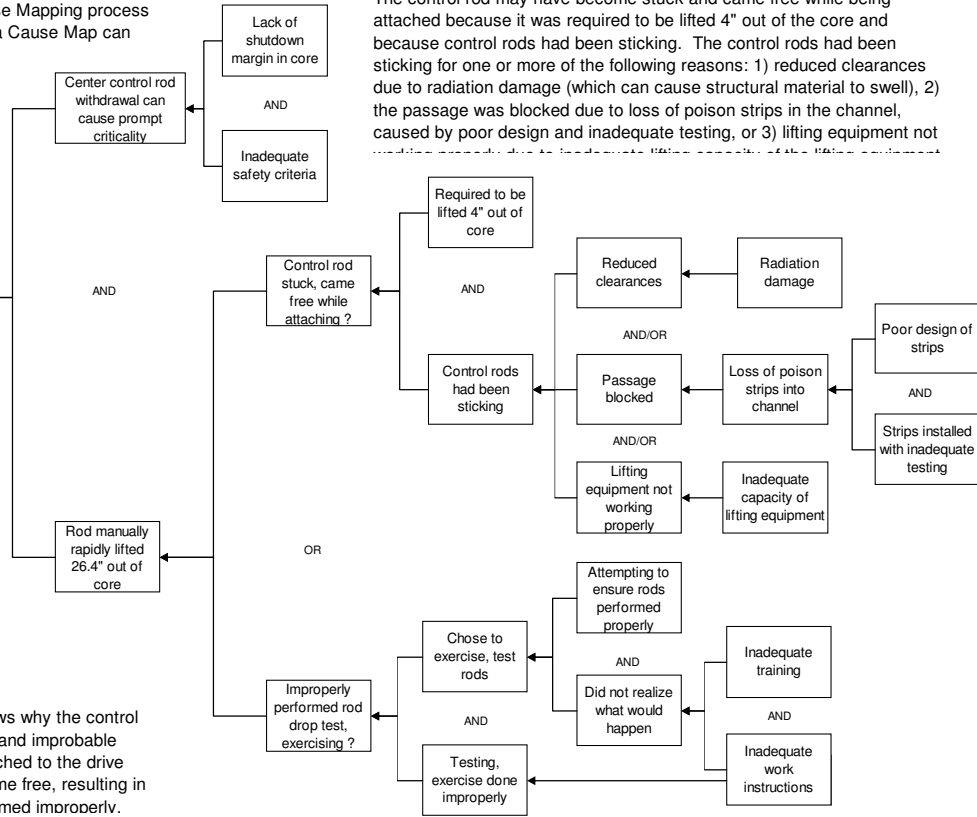
Withdrawal of the central rod can cause prompt criticality due to a lack of shutdown margin in the core, and inadequate safety

Because most of the evidence was so effectively destroyed, nobody really knows why the control rod was lifted out of the core. There are two theories (disregarding the bizarre and improbable murder/suicide theory): 1) the control rod got stuck while being lifted to be attached to the drive mechanism, and, as the operator was exerting greater force on it, suddenly came free, resulting in a lift far greater than intended. or that an rod droo testina/exercising was performed imroperlv.

The control rod may have become stuck and came free while being attached because it was required to be lifted 4" out of the core and because control rods had been sticking. The control rods had been sticking for one or more of the following reasons: 1) reduced clearances due to radiation damage (which can cause structural material to swell), 2) the passage was blocked due to loss of poison strips in the channel, caused by poor design and inadequate testing, or 3) lifting equipment not

It's also possible that an exercising/testing was potentially improperly performed. This could have occurred because the operators chose to exercise/test the rods, attempting to ensure that they would perform properly, and because they didn't realize what would happen. This is because of inadequate training and inadequate work instructions. The testing was also potentially done improperly due to inadequate work instructions.

On a positive note, the SL-1 incident did initiate some positive changes in the nuclear industry. Most notably, reactor design has improved and incorporated a "one-rod stuck" criteria which specifies that a reactor can NOT go critical by the removal of any one control rod. Additionally, procedures and training have gotten more intense and more formal, and planning for emergencies has increased.
