**Step 1. Outline**

**Bluff Collapse Releases Coal Ash  
Lake Michigan, October 31, 2011**

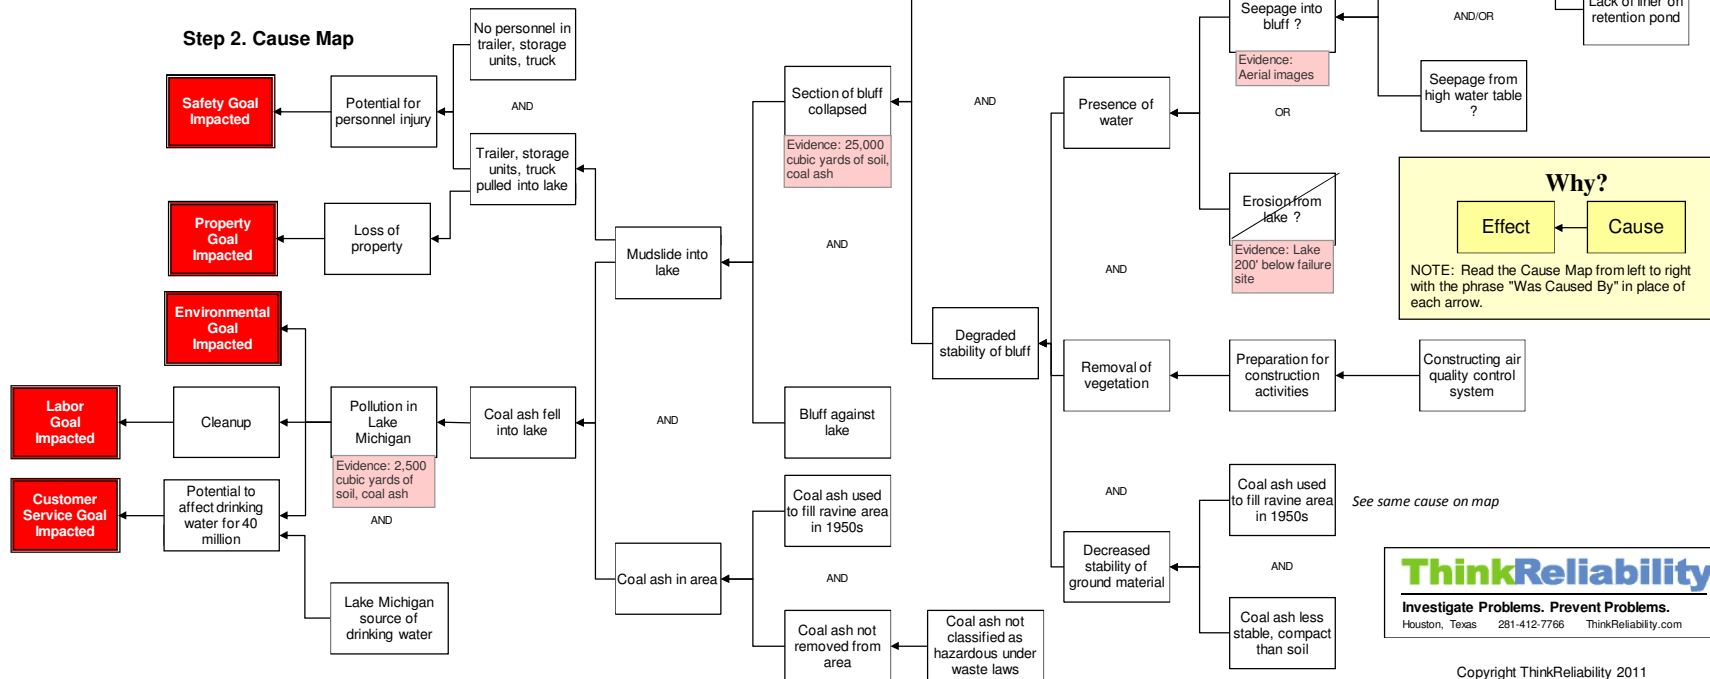
**Step 2. Cause Map**

Although the safety goal was not impacted by this incident, there was the potential for personnel injury. Additionally, the environmental, customer service, property and labor goals were impacted by the pollution of the lake, loss of property and necessary cleanup. The causes for these impacts to the goals can be examined in a Cause Map, or visual root cause analysis.
